non-destructive methods for slab investigations

Non Destructive Techniques for CONCRETE SLAB AND STRUCTURAL INVESTIGATIONS

GBG Australia

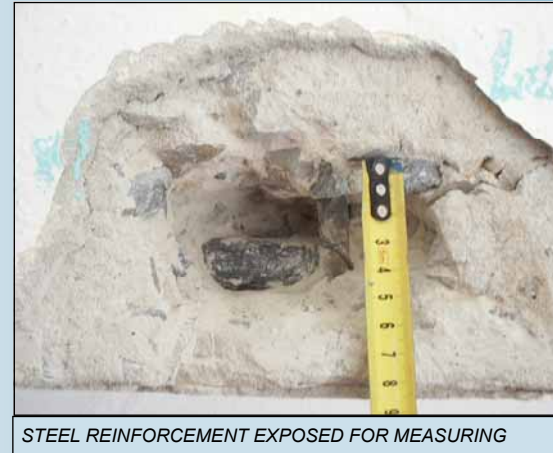
STEEL REINFORCEMENT EXPOSED FOR MEASURING

Verification of engineering design for existing concrete slabs traditionally involved exposure of reinforcement at multiple sites across a slab, with no information available between exposures. This information is of limited use for verification of construction, and of no use for the calculation of loadings for building alteration. Non-destructive techniques allow validation of entire slab construction. Detail of mesh and bar layout can be plotted, and with limited physical disruption, verification of bar diameters can be achieved. GBG Australia is actively expanding the use and capabilities of applied physics and micro-geophysical techniques for construction verification and validation.
