## GBG Australia

## Non Destructive Techniques for HERITAGE & ARCHAEOLOGICAL ASSESSMENT

# Applications for non-destructive techniques

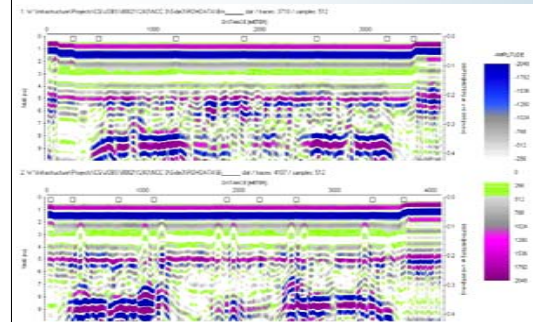
RADAR SCAN THROUGH STONE FACADE

Comprehensive surveys (to 350 mm depth ) were carried out using a 1.2GHz antenna, which was hand-drawn over the surface. Profiles were correlated with data from a metal detector, to confirm accurate locations of the metal pins.

The condition of the fixing pins was determined by comparing the amplitude of reflections recorded from each element. The results of this investigation enabled the Client to plan specific, and therefore economical, maintenance of these important Gothic Revival style features.

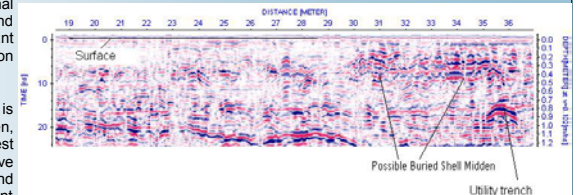
RADAR PROFILE OF A HOLOCENE REMNANT BEACH RIDGE

The culturally sensitive nature of these investigations is respected and confidentiality of results is observed. Often, there may be no photographs taken of the site at the request of the client. While GPR data does not give definitive answers, areas of interest within the site are mapped and recommendation given as to the location of relevant features. These results may be used to plan further physical investigation such a spitting and trench excavations. This approach saves time and is more economically viable than destructive testing of the whole site.
