GBG Australia

Non Destructive Techniques for

STRUCTURAL ASSESSMENT

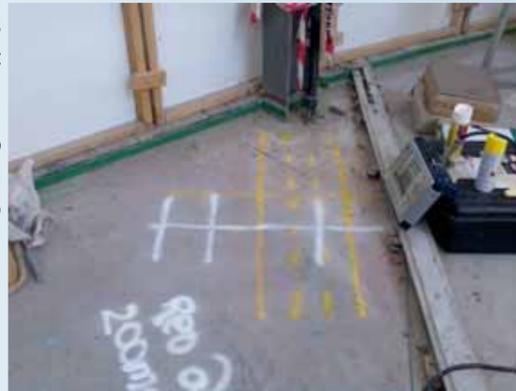
In many cases intra-slab steel and services can be marked in situ prior to penetrations or coring. This allows for minimal disruption to the site as both procedures can be completed without interrupting operations on two occasions.

INTRA-SLAB STEEL MARKED ON SITE DURING SURVEY

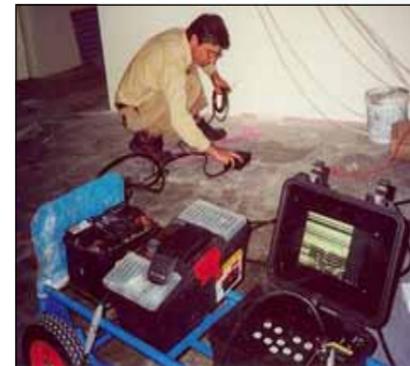
The slabs were surveyed using a 1.5 GHz antenna with a maximum profile depth of 400mm providing the best resolution of subsurface steel, and allows distinction between signals recorded from tendon ducts and reinforcement bars.

USING 1.2GHz ANTENNA FOR TENDON DUCT LOCATION

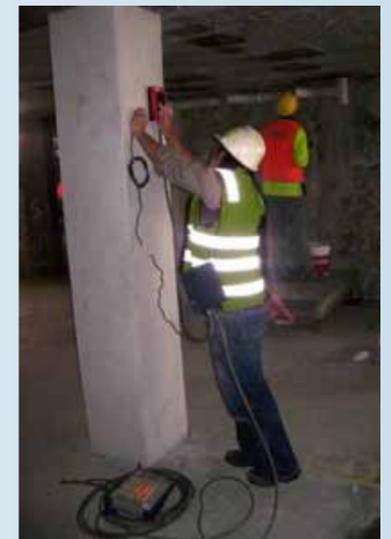
The main investigative method was high frequency impulse radar which provided the steel detail and floor thickness. This was complemented with a protovale CMS covermeter for greater accuracy of bar diameters and a L/CR schmidt hammer to give indicative concrete hardness.

1.5GHz ANTENNA USED TO SCAN CONCRETE COLUMNS
