GBG Australia

Non Destructive Techniques for

STRUCTURAL ASSESSMENT

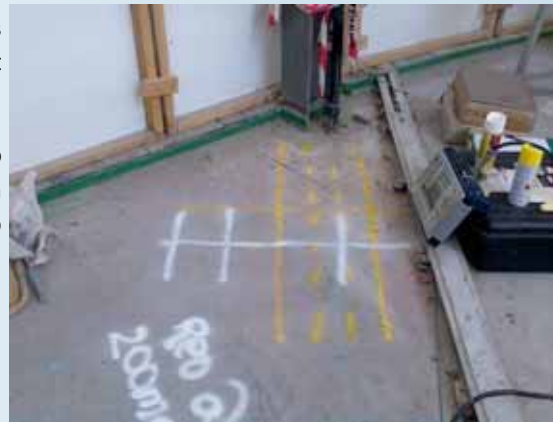
INTRA-SLAB STEEL MARKED ON SITE DURING SURVEY

In many cases intra-slab steel and services can be marked in situ prior to penetrations or coring. This allows for minimal disruption to the site as both procedures can be completed without interrupting operations on two occasions.

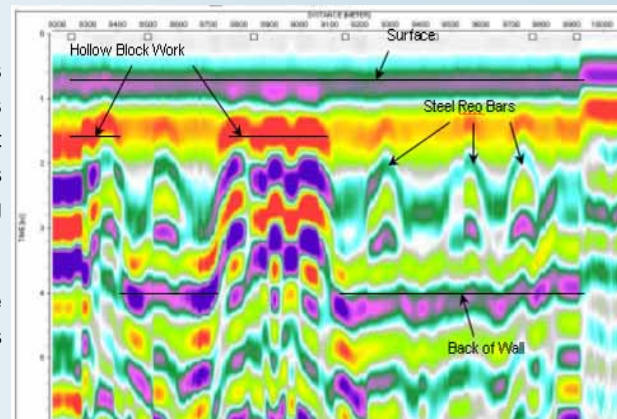
A TYPICAL RADARGRAM ALONG A VOIDED BLOCK COURSE.

During a survey, an antenna is used to pulse radio energy into the wall and to receive reflected responses from interfaces between materials of dissimilar electrical properties, e.g. concrete / air. A radargram is built up of continuous scans along a traverse, effectively portraying a slice through the wall. The recorded reflections may be analysed in terms of shape, travel time and signal amplitude. In the case of an unfilled cavity within the wall, the radargram produces a high amplitude responses as most of the energy is reflected back and minimal energy propagates through the wall back.

The data was interpreted using REFLEX software and void locations were shown on schematic CAD drawings. Close to half the walls had large areas of hollow block work. Vertical steel reinforcement bars were found in all the walls at spacing of ~400mm. These results were used by the structural engineer to coordinate remedial grouting of the defective block work.

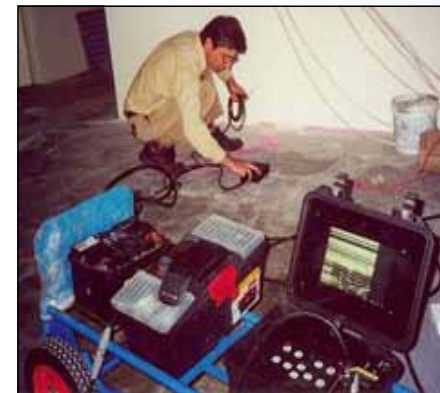
USING 1.2GHZ ANTENNA FOR TENDON DUCT LOCATION

The slabs were surveyed using a 1.5 GHz antenna with a maximum profile depth of 400mm providing the best resolution of subsurface steel, and allows distinction between signals recorded from tendon ducts and reinforcement bars.

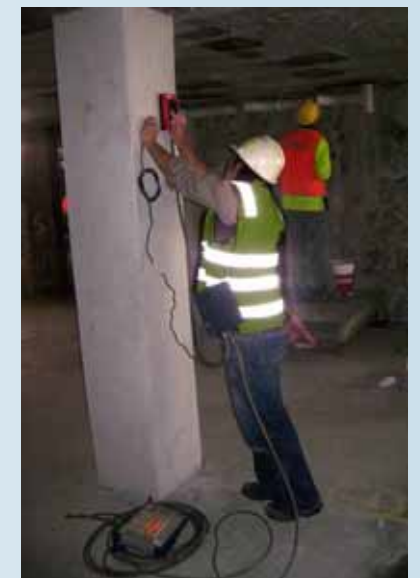
1.5GHZ ANTENNA USED TO SCAN CONCRETE COLUMNS

The main investigative method was high frequency impulse radar which provided the steel detail and floor thickness. This was complemented with a protovale CMS covermeter for greater accuracy of bar diameters and a L/CR schmidt hammer to give indicative concrete hardness.
