GBG Australia

Non-destructive techniques for TREE ROOT INVESTIGATIONS

NON DESTRUCTIVE METHODS FOR MAPPING TREE ROOTS.

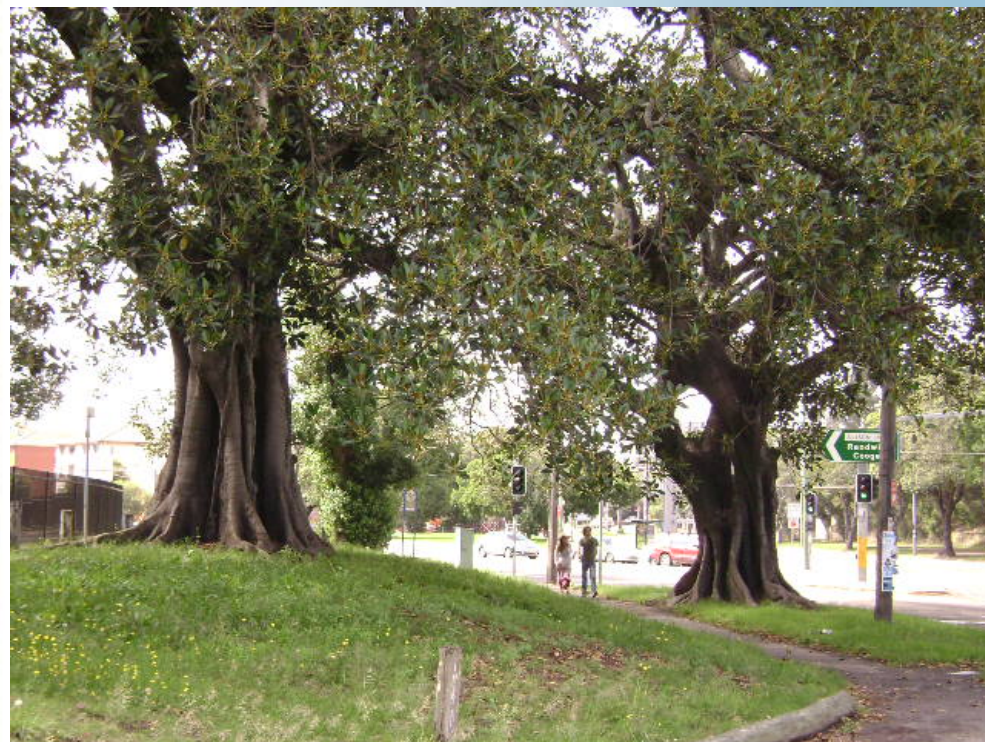
Two Fig trees requiring non-destructive mapping before the installation of an underground sewerage main, Randwick, NSW.

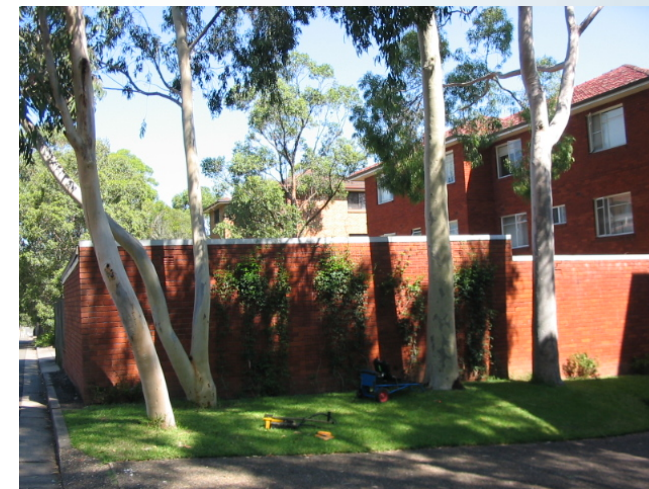
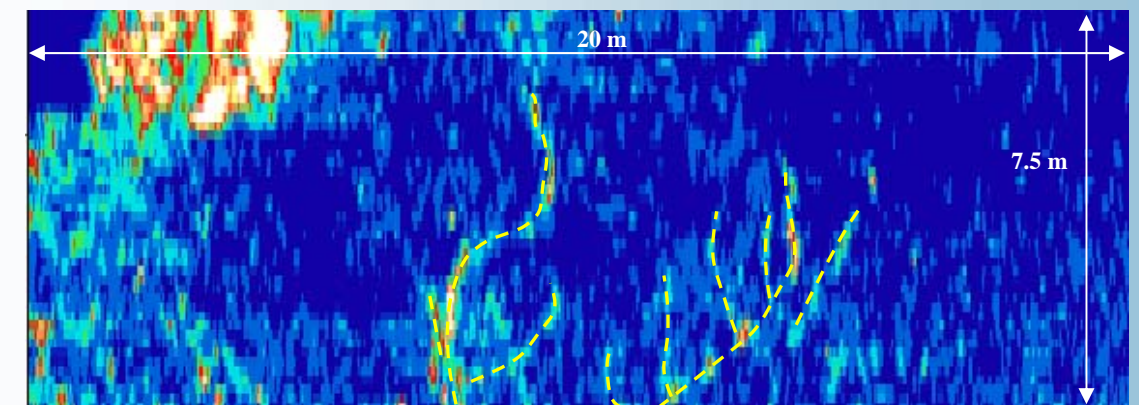
Front page: Site photo from another successful tree root mapping (top). GPR depth slice (bottom) at 350 mm showing the position of tree roots in plan view. Depth slices are generated by collecting closely spaced parallel GPR profiles.

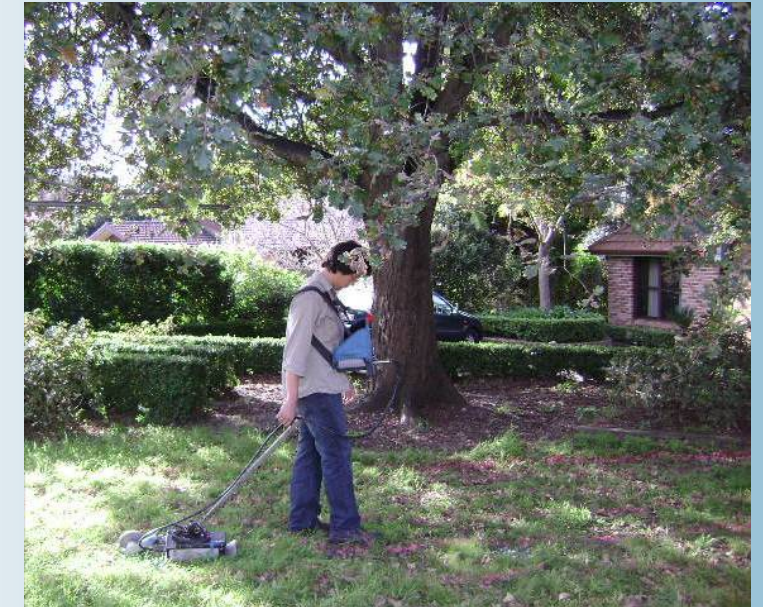
Site photo (right). The GPR antenna is moved along the ground surface at a slow pace continuously collecting subsurface images. The data is streamed to the control unit enabling the operator to QC the data in real time.

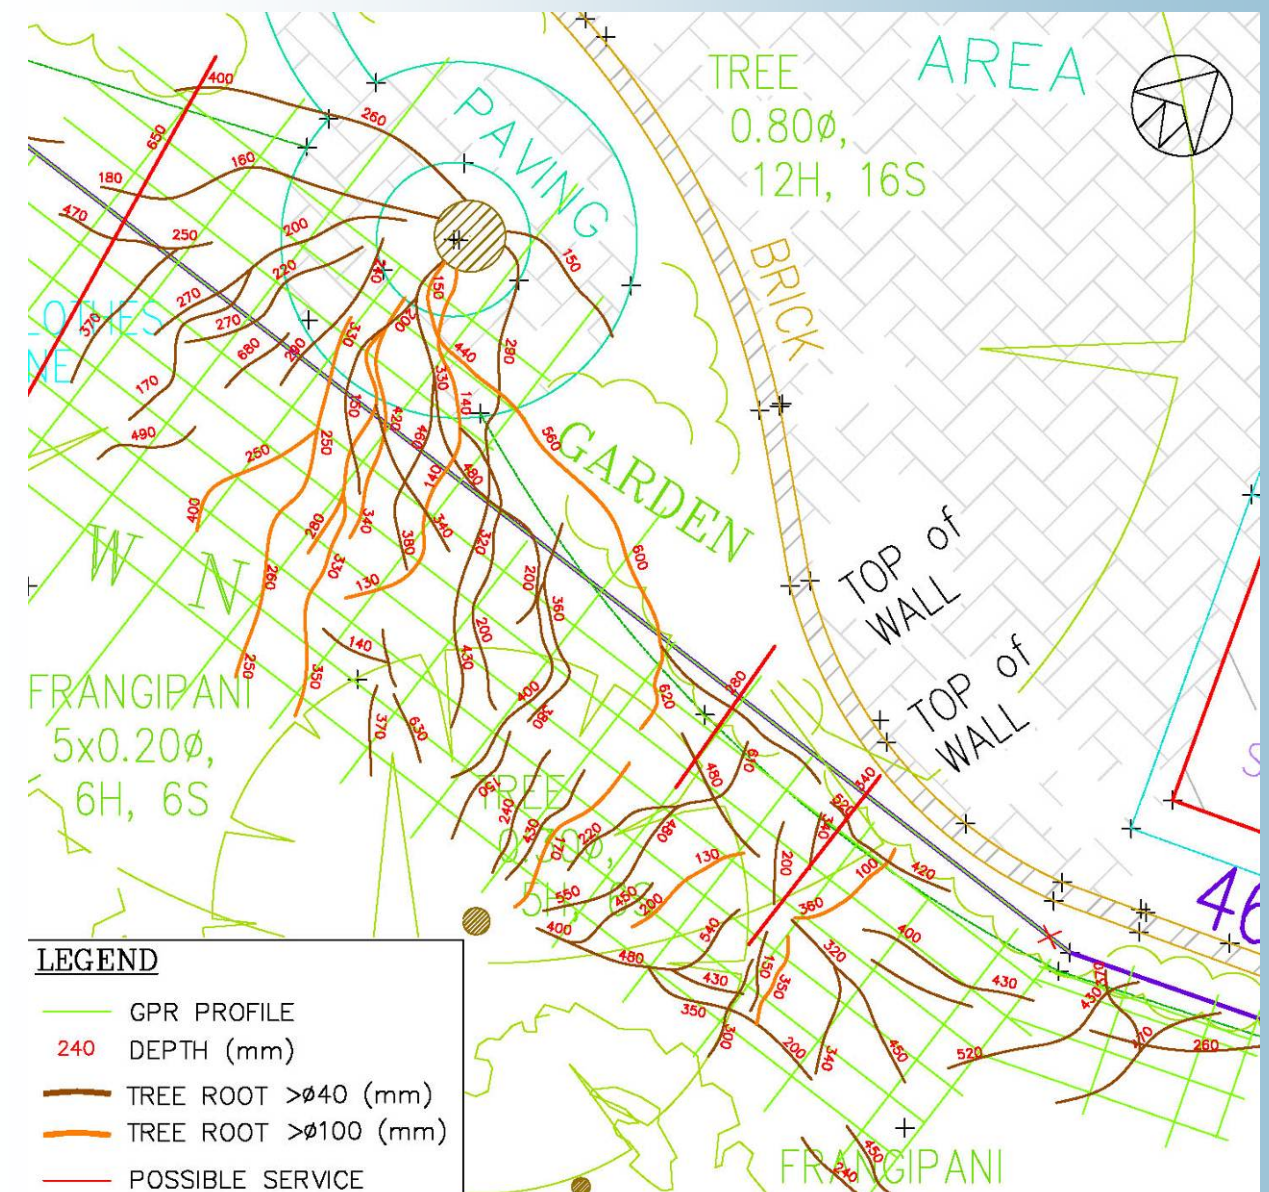
The results of the investigation (below) were overlaid onto a survey drawing of the site. An extensive root system from the targeted tree was mapped. Features are shown as per the legend.

The results of the investigation were overlaid onto survey plans of the site and shows the location of and depth to the identified tree roots. The GPR investigation mapped an extensive root system emanating from the targeted tree. Roots emanating from other trees in the survey area were also identified. Two classes of roots were identified: smaller roots between 40 and 100 mm in diameter are shown in brown whilst larger structural roots greater than 100 mm in diameter are shown in orange. Tree roots have been identified up to a depth of 650 mm from the surface.
