GBG Australia

BRIDGE INVESTIGATIONS

Non Destructive Techniques for BRIDGE INVESTIGATIONS

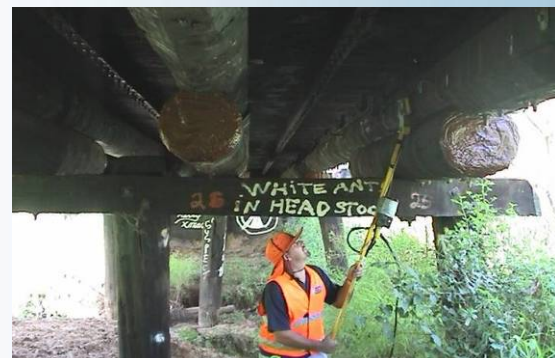
Radar profiling timber girders at Redbank bridge QLD.

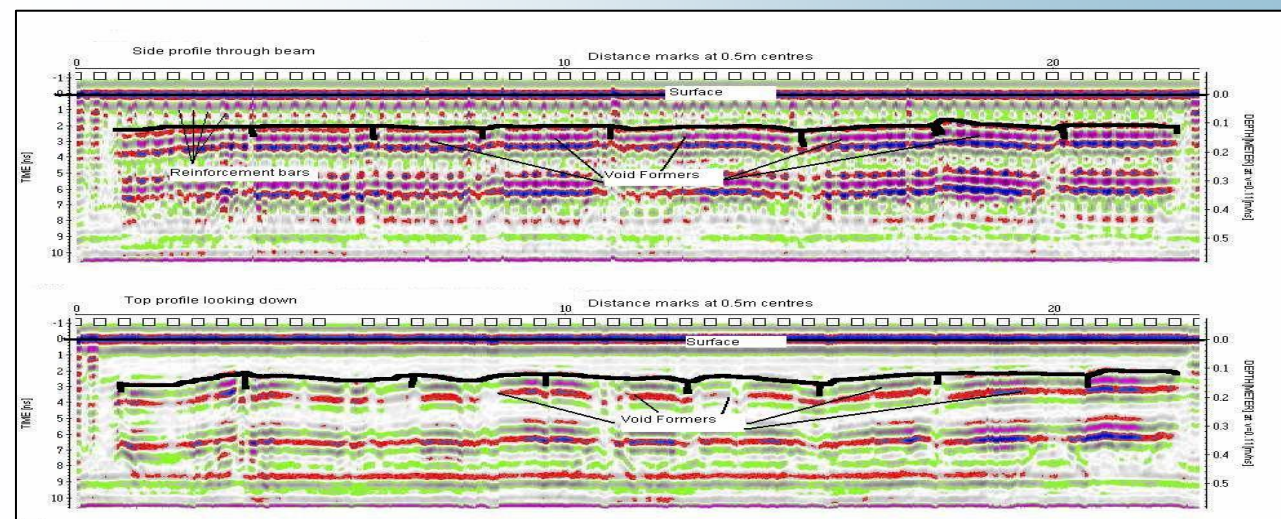
1.5GHz impulse radar profiles through side and top of concrete beam.

Data profiles were collected using a 1.5GHz frequency antenna along the centre line of the top, side and bottom of each beam. From these profiles the position of void formers and the internal reinforcement frame can be plotted and accurately positioned to compare with the specification. (refer to data profile example).

The investigation found that the radar profiles could quickly indicate on site whether void formers had moved during casting and could target the void former locations within the beam. Calibration could be carried out on site by drilling a small bore hole through the top of the targeted location for inspection with a wire hook. After a few calibration measurements the radar was able to profile and plot void former depth to an accuracy of 4mm from the surface profiled.
